Fauntleroy Creek Channel Conditions Report 2001

Seattle Public Utilities

Earth Systems
19729 207th Ave SE
Monroe, WA 98272-9370

December 2002

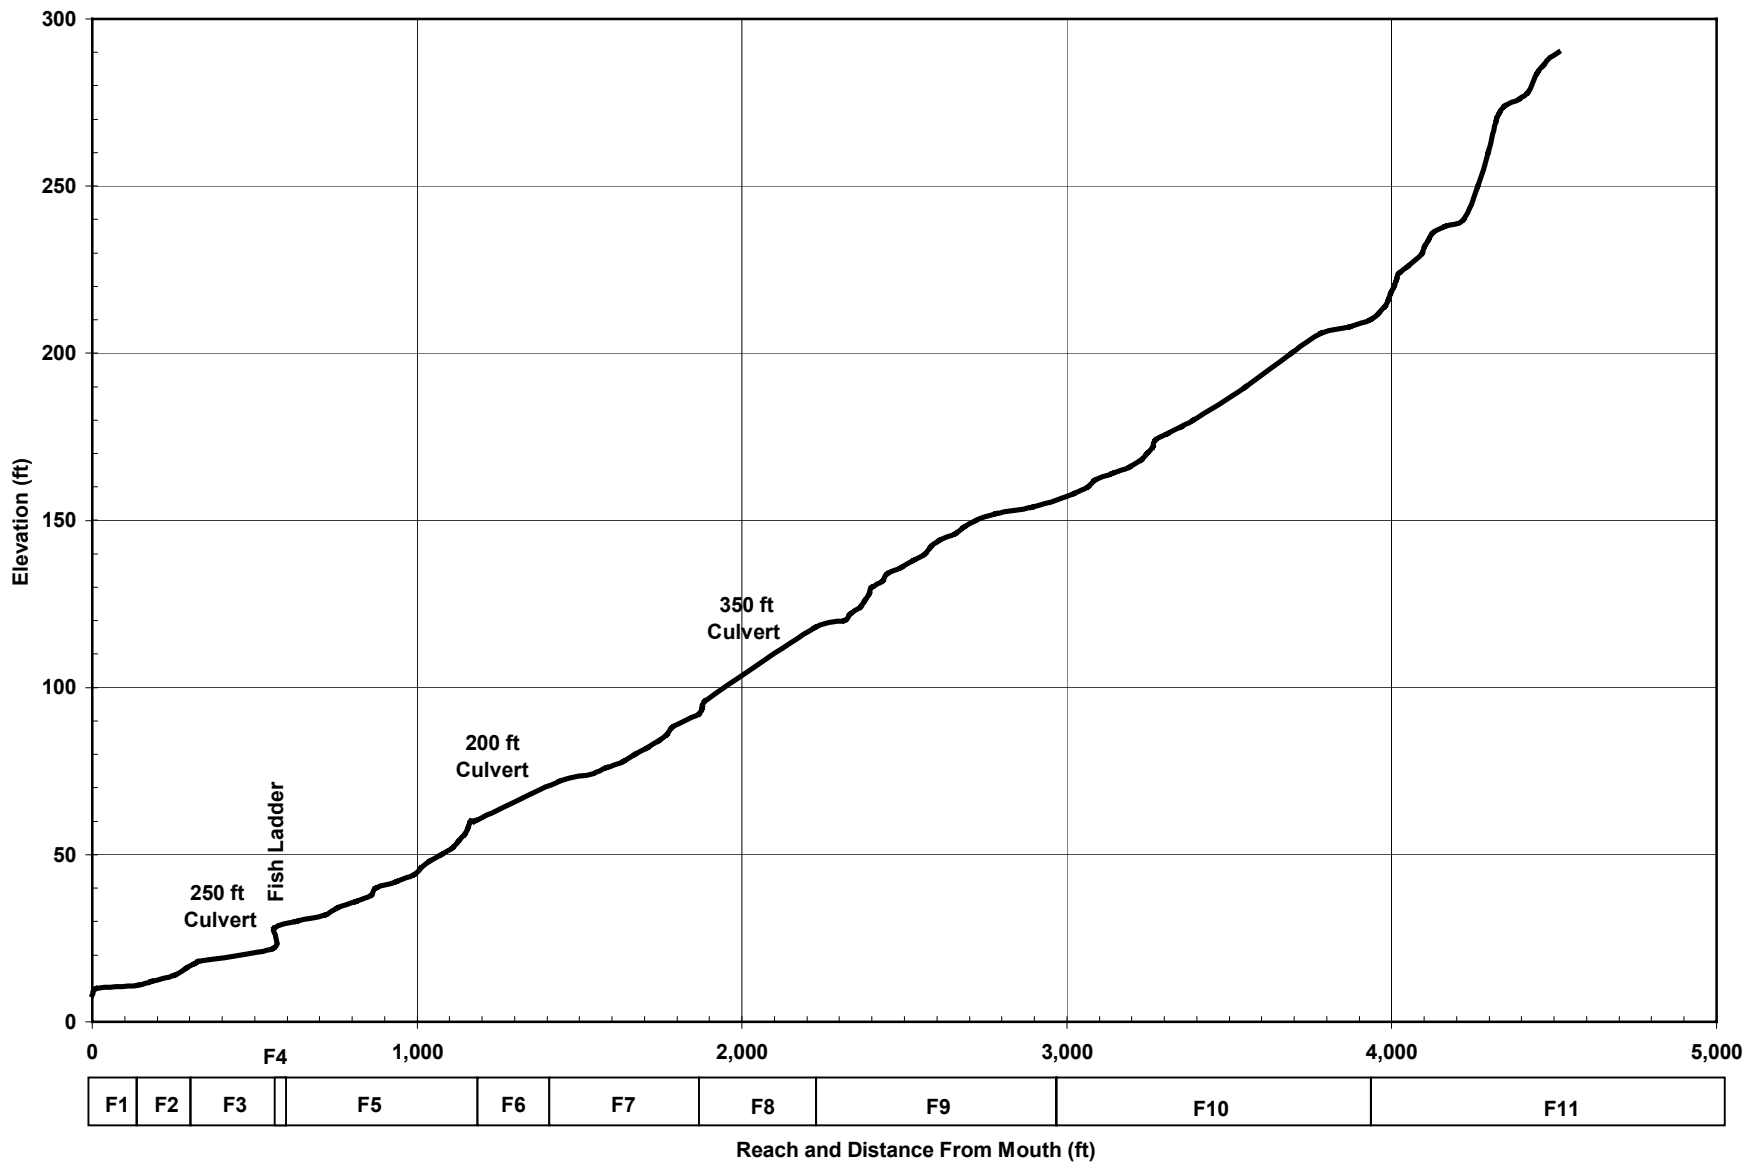
Figure 4-1. Fauntleroy Creek Channel Profile

Knickpoints (also called headcuts) are an abrupt change in channel gradient within the channel profile (Figure 4-1). Knickpoints formed of erodible material migrate upstream, which causes the bed elevation to drop abruptly. Upstream passage of a knickpoint can transform the channel from a relatively wide, shallow shape to a narrow, deep shape with steep, eroding bank. The long-term (thousands of years) erosion into the glacial valley floor of Fautleroy Creek, up to about SW Orchard St., is the only apparent knickpoint. Other knickpoints were not obvious in Fautleroy Creek, probably because the lower channel is locked in between grade controlling culverts and the upper basin has active valley wall slopes supplying sediment to the narrow valley bottom.
